Table of Contents

Today, roof bolting is, by far, the most common support system used in South African collieries. Because it is more economic than other methods; it saves material and manpower consumption. Most important of all, roof bolting is more effective and efficient because it is an active support method, utilising the rock to support itself by applying internal reinforcing stresses. Furthermore, rock bolting can be satisfactorily used to meet a variety of geological conditions and various support requirements. Roof bolts are available in many forms and the methods to attach them to the rock mass are almost as varied. Full column single resin bolts, full column slow-fast combination resin bolts, resin point anchors and mechanical anchors are the most widely used support systems used in South Africa. Significant advances have been made over the last 20 years in all elements of roof bolting. The design of roof bolt patterns has also been improved. However, studies into the causes of falls of ground show that falls of ground (FOG) have been the major cause of fatalities in South African collieries since 1970.

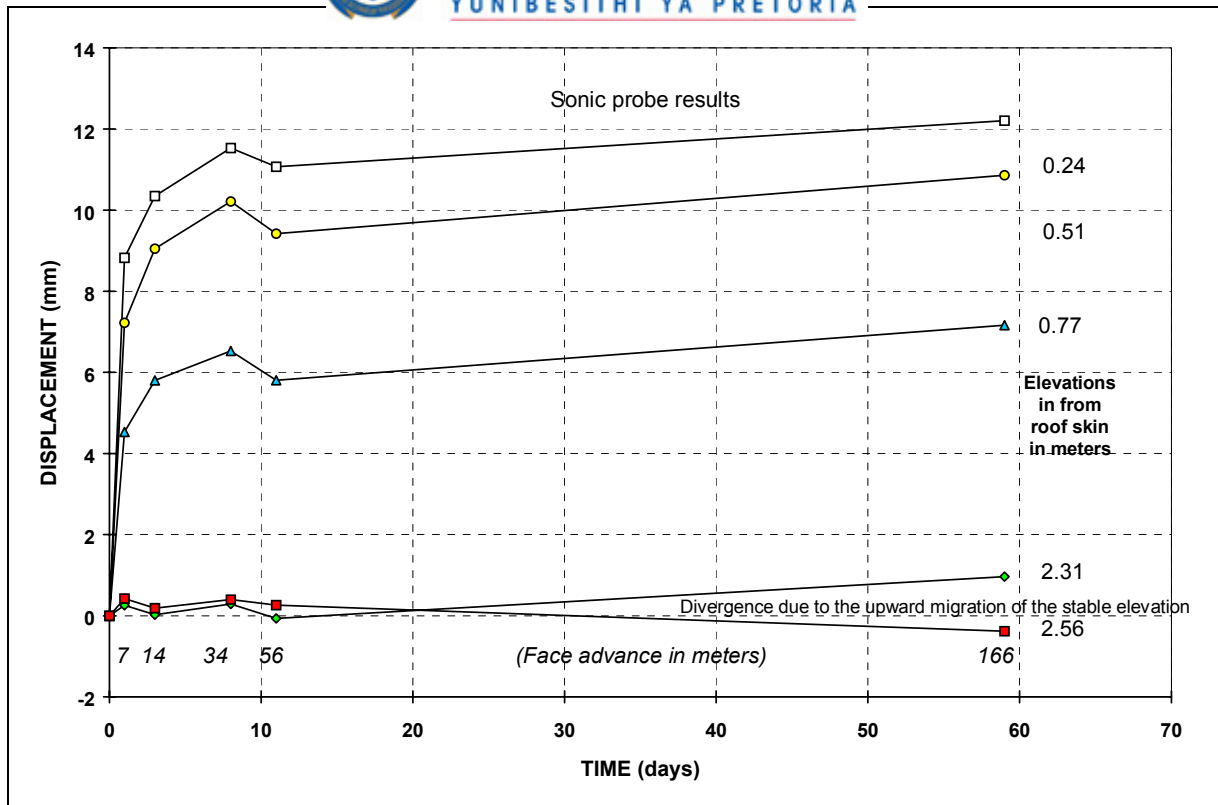
Figure 3-41 Colliery 'D' area 2 site 2 displacements

The full displacement with time profile of a variety of elevations up to 2.5 m into the roof at site 2, area 2, Colliery 'D' are presented in Figure 3-41. Between days 11 and 59, the face was advanced from 56 m to 166 m. During this period all the strata between the 0.24 m and 2.31 m elevations in the roof deflected downwards in unison (upwards on the graph). There was no evidence of any relative displacements occurring within the 0.24 m to 2.31 m strata horizon. With time, the roof within this region deflected by about 1.0 mm allowing an additional 2.31 m elevation to become detached and deflect by a similar amount. This upward migration of the stable elevation is evident from the divergence of the 2.31 m and 2.56 m anchors in Figure 3-41.

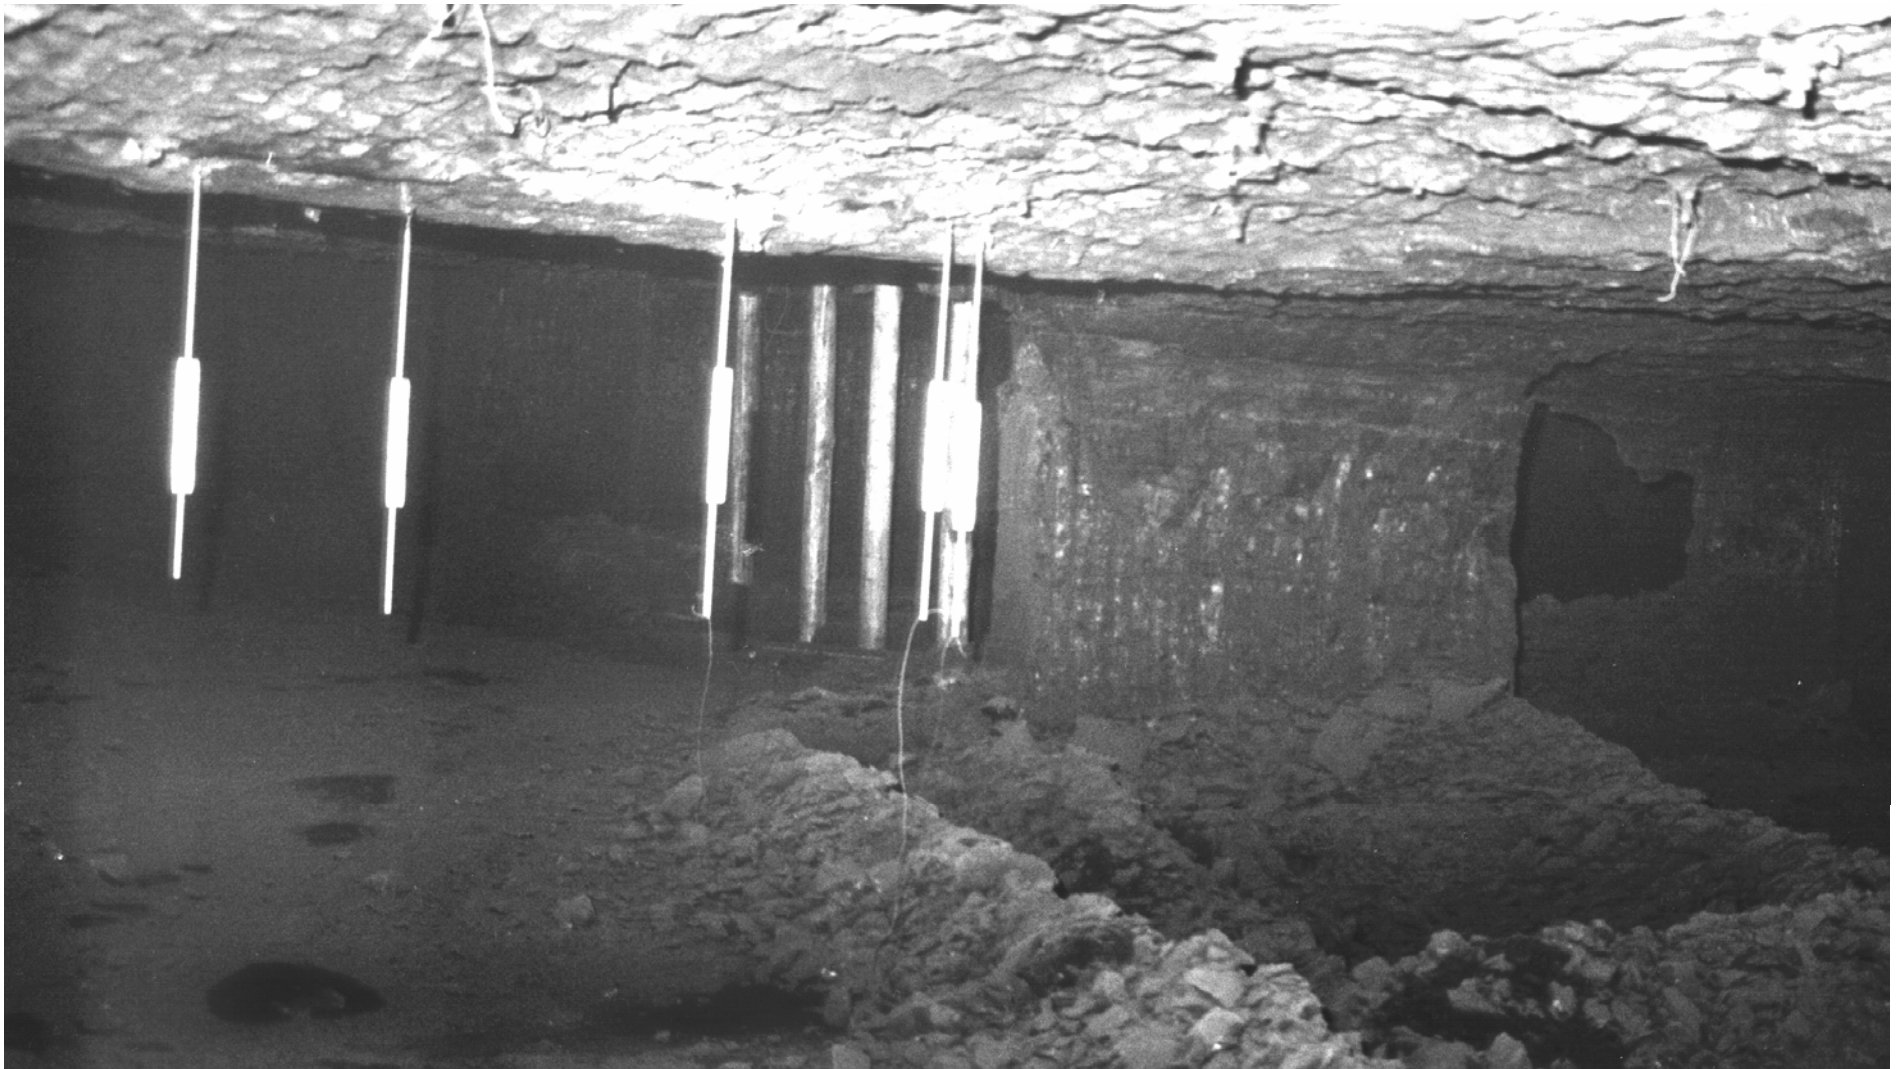
Figure 3-50 Experiment site taken on day nine

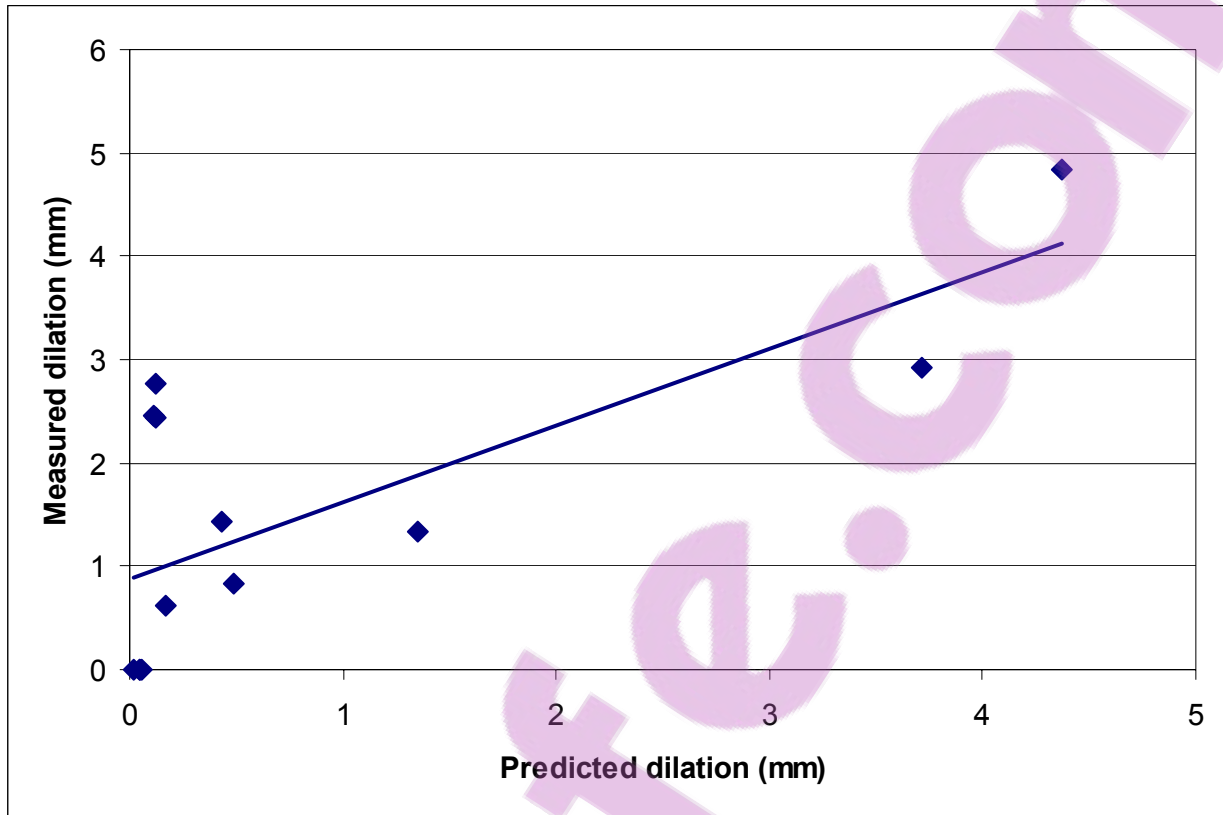
Figure 4-23 Relationship between measured and predicted dilation

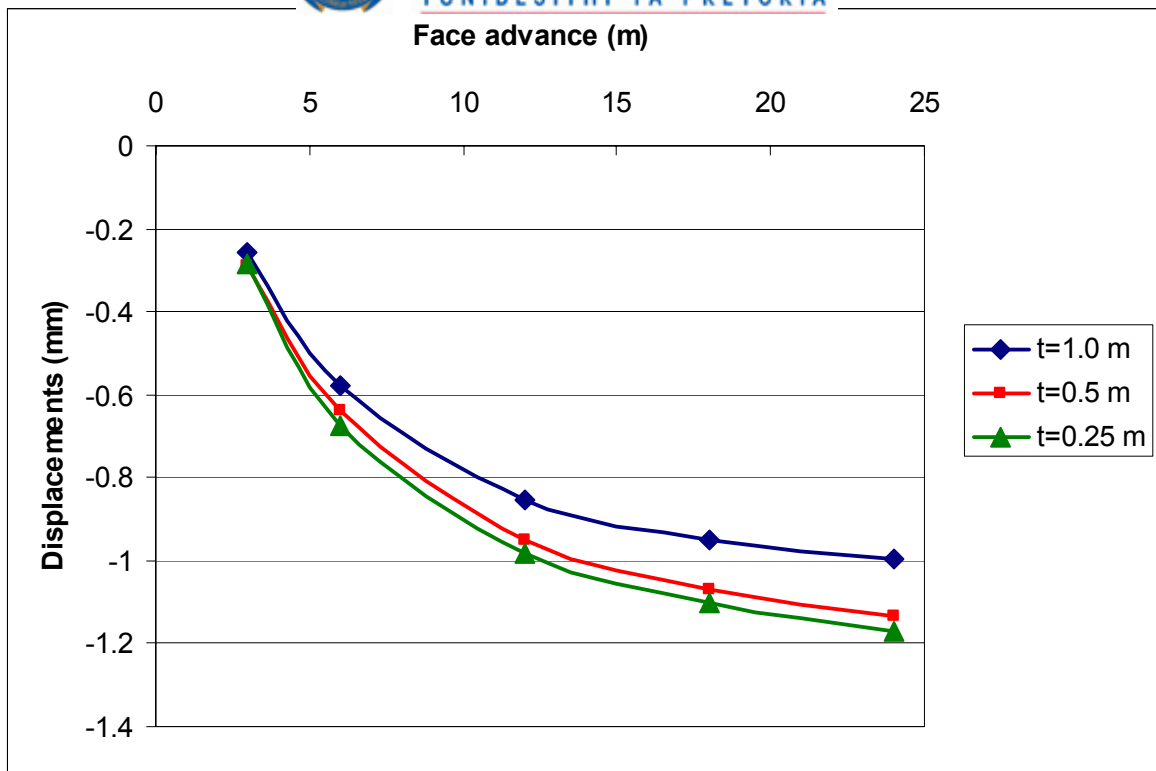
Figure 4-27 Effect of the thickness of the immediate layer on roof deformations

The effect of the thickness of the immediate layer was also investigated using the same model. In this model the *k*-ratio was kept constant at 3.0, and 0.25 m, 0.5 m and 1.0 m thick, immediate layers were modelled. The results indicated that decreasing the thickness of the immediate layer increases the displacements in the roof, Figure 4-27. This trend was also apparent in the monitoring, indicated by relatively good correlation between measured deflections and the beam predictions.

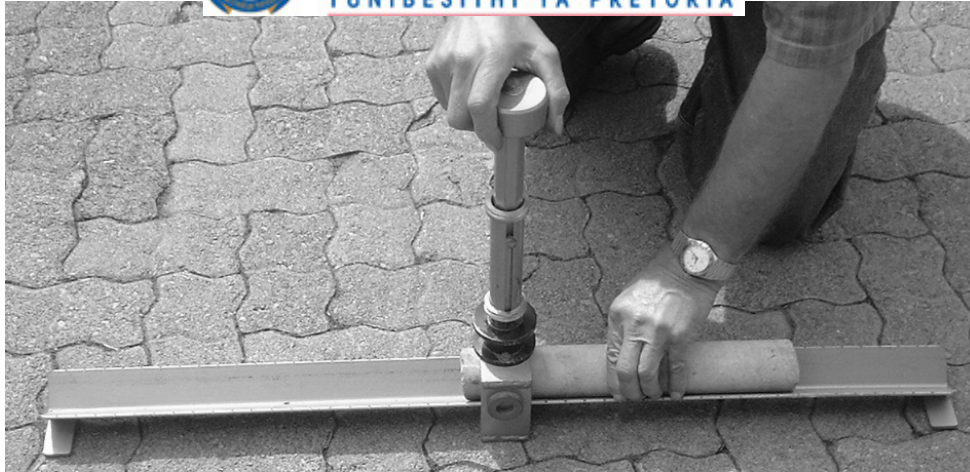
Figure 5-3 The Impact splitting equipment

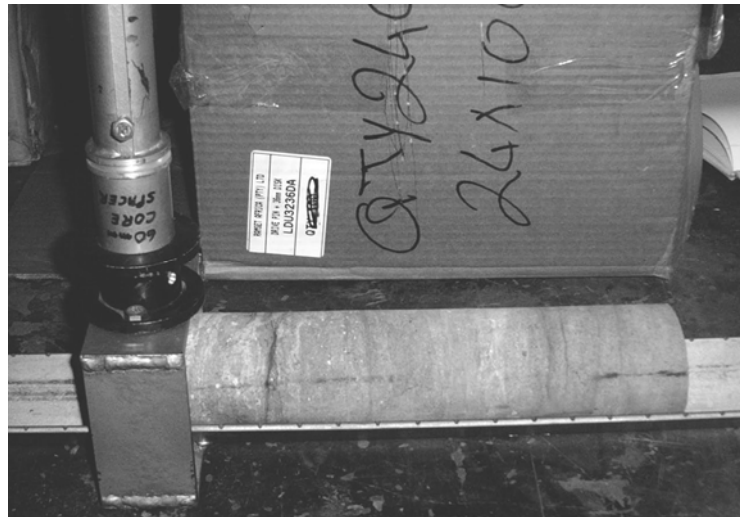
Figure 5-5 A fine to medium grained sandstone or “grit” unit before impact splitting, taken from borehole ARN 4968

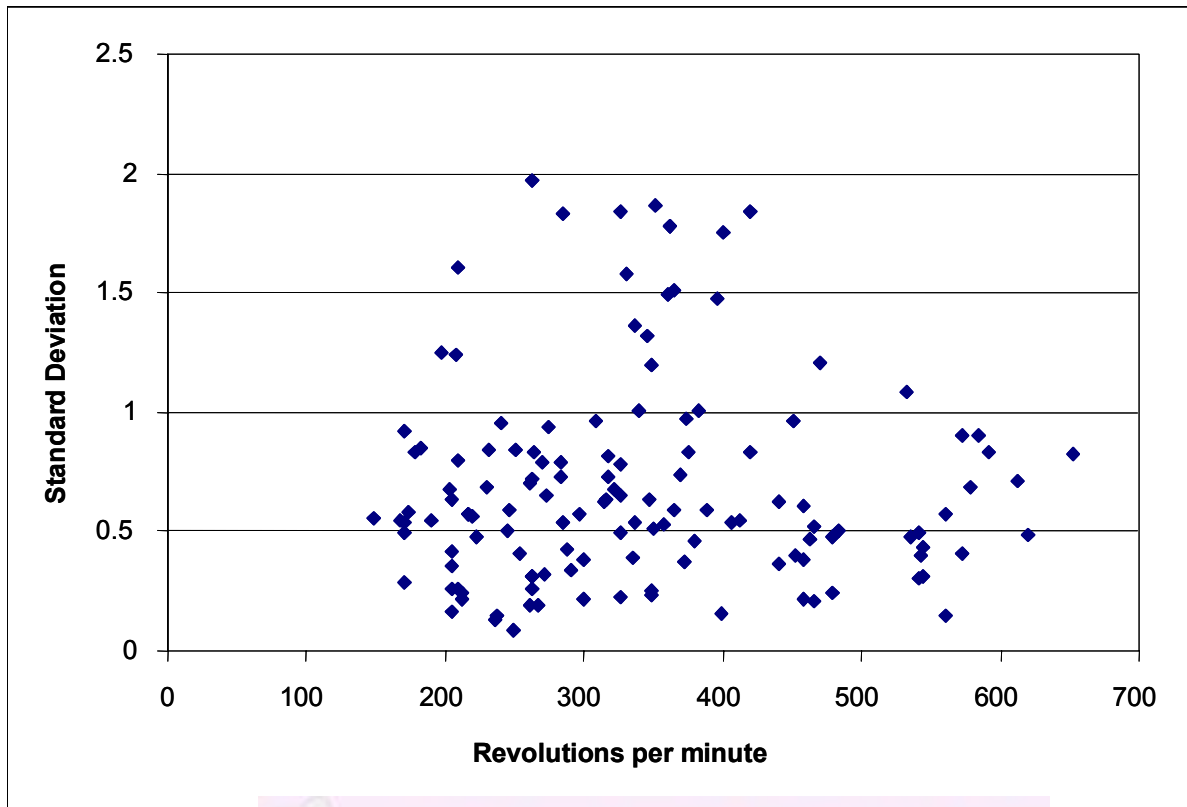
Figure 6-19 Drilling speed against hole profile standard deviation

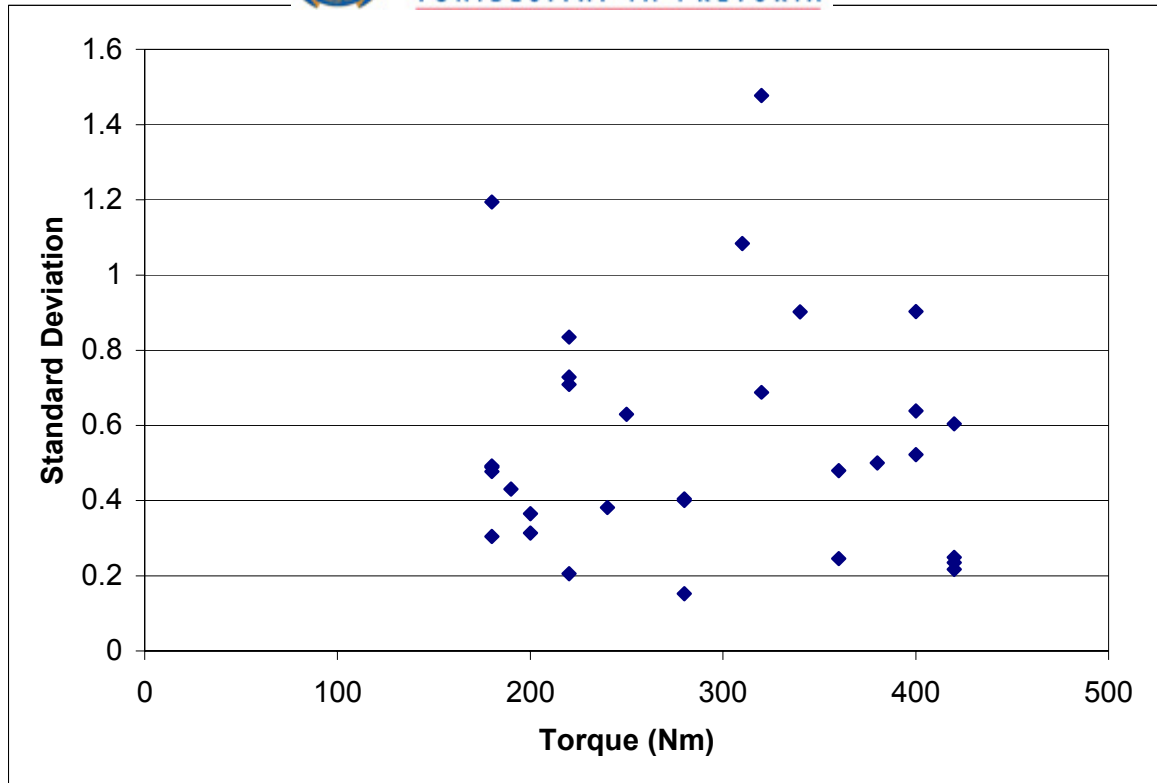
Figure 6-24 Torque against hole profile standard deviation in machines using dry flushing system

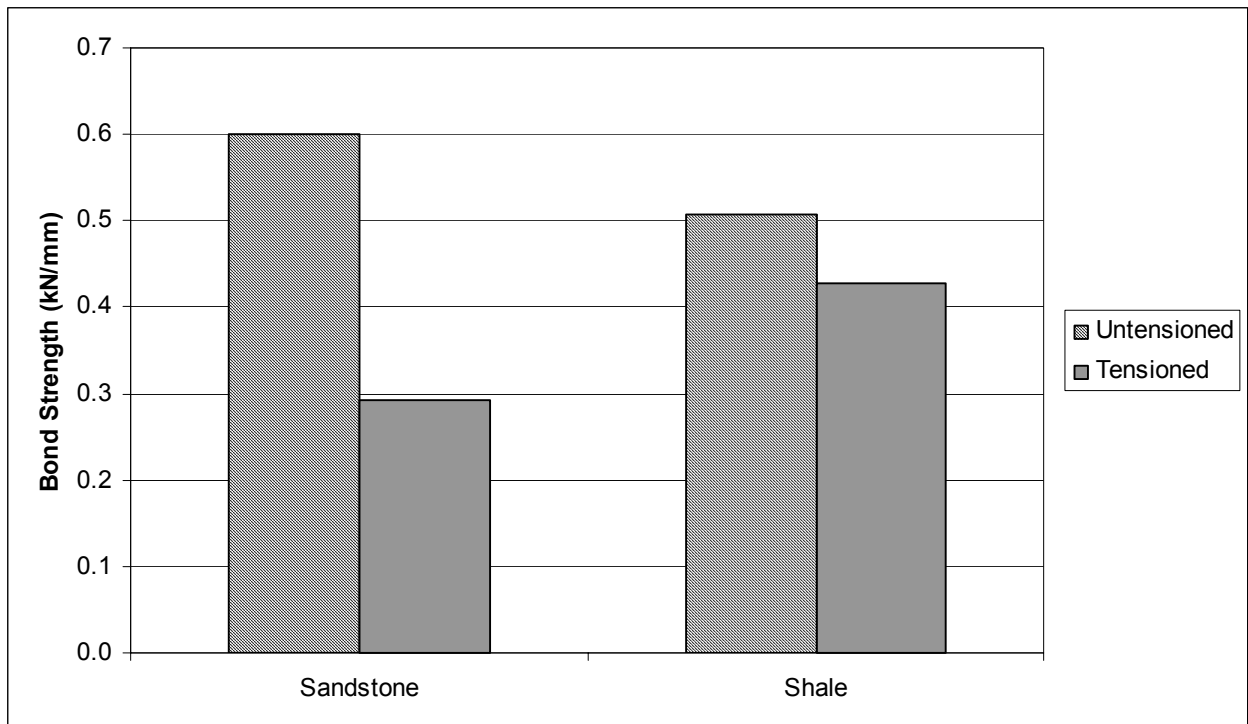
Figure 6-31 Effect of tensioning on bond strength

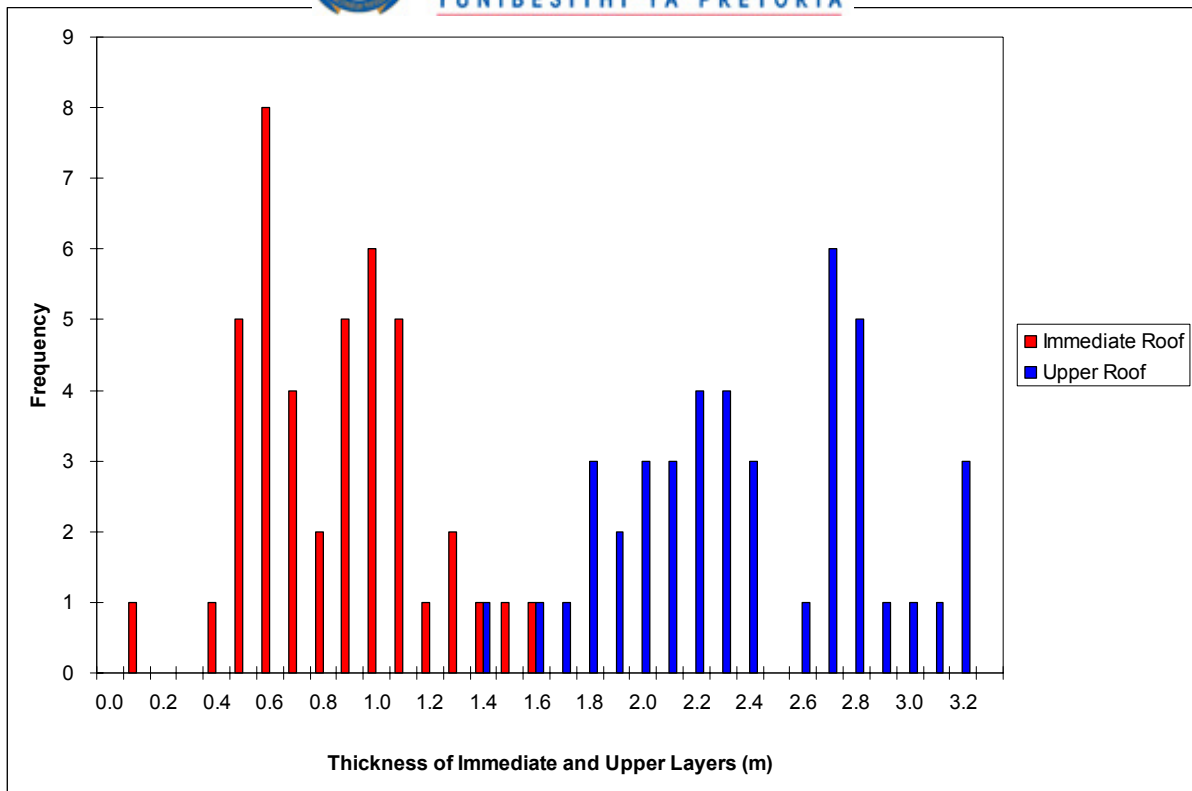
Figure 7-15 Thickness of immediate and upper roof obtained from borehole logs

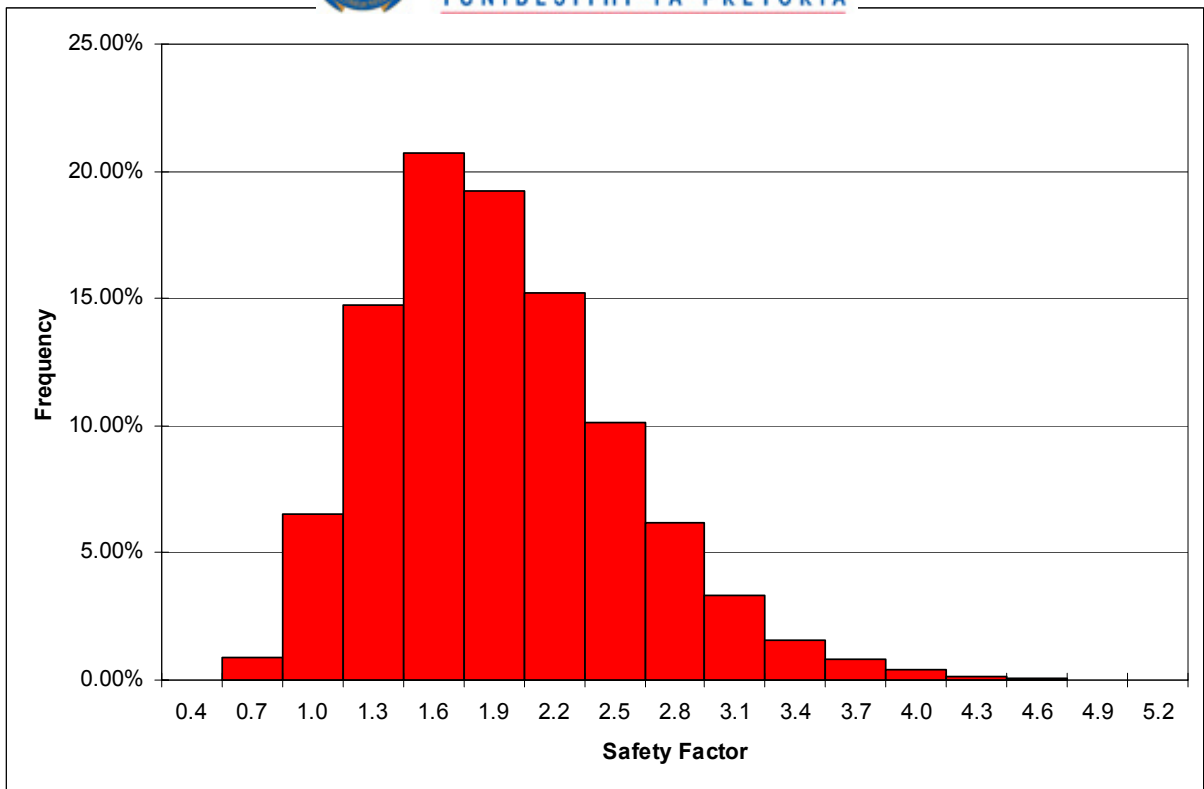
Figure 7-23 *Distribution of safety factors of upper coal layer in suspension mechanism*

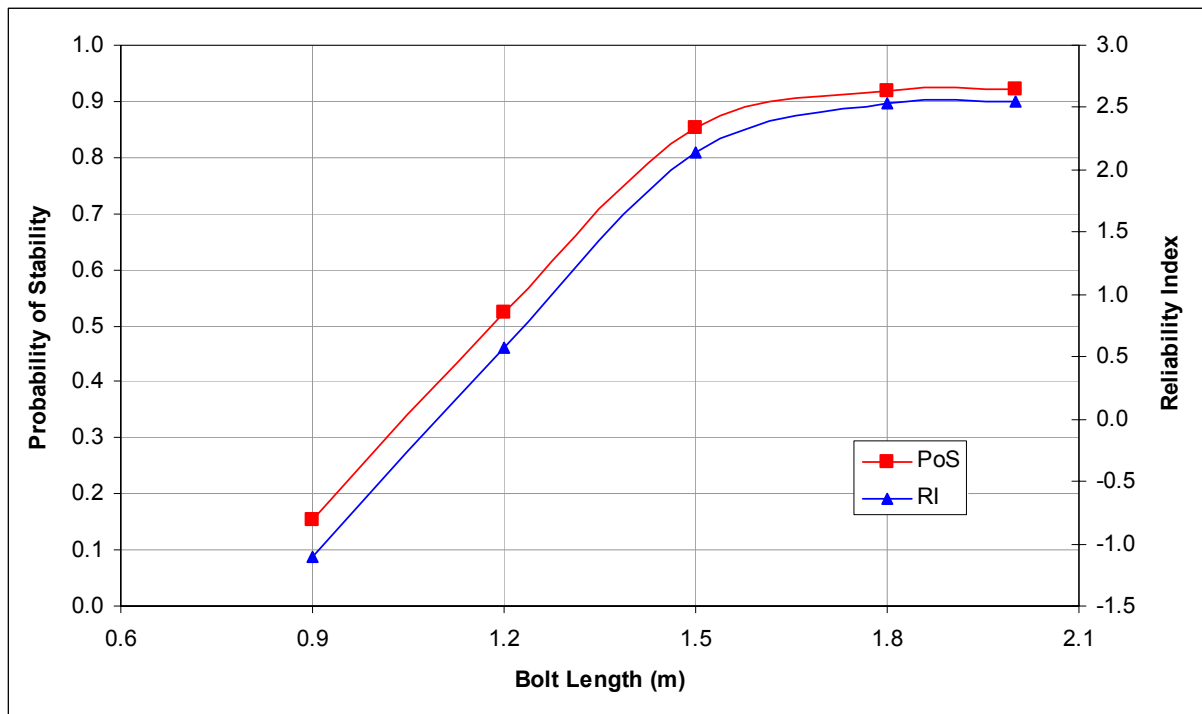
Figure 7-25 PoS and Reliability Index for suspension mechanisms for different roof bolt lengths

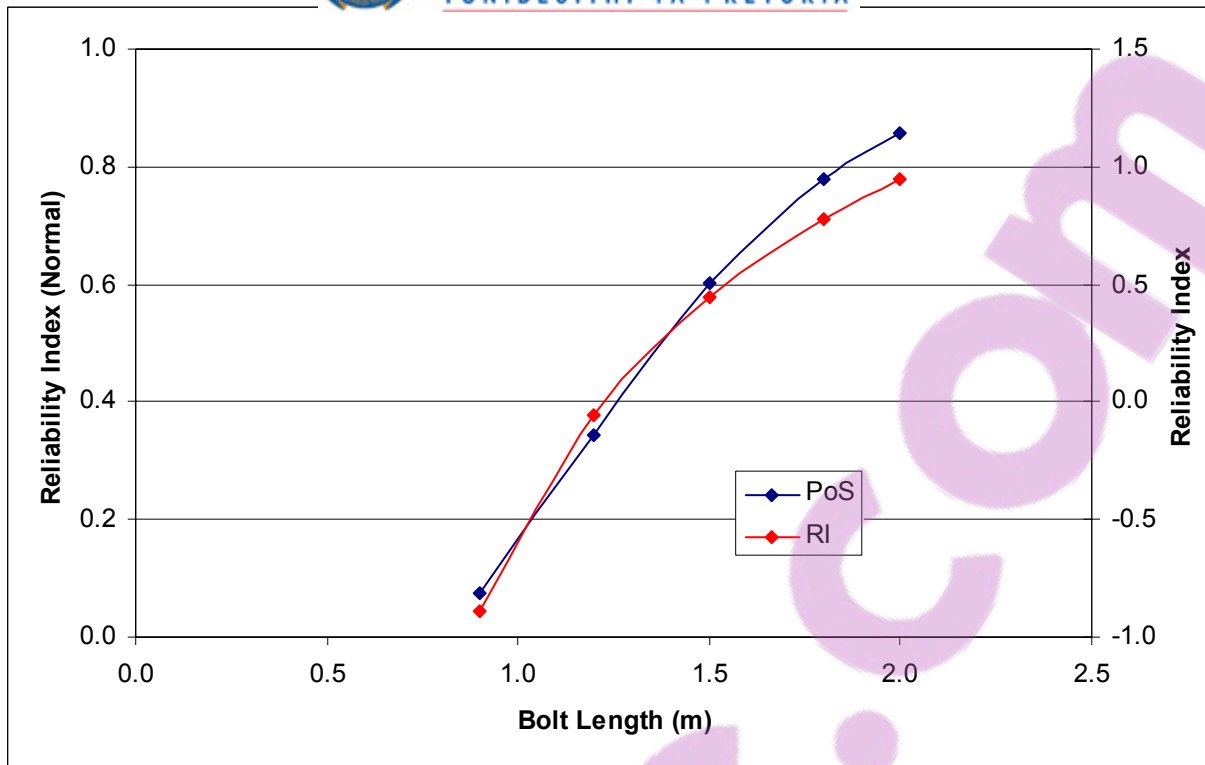
Figure 7-26 Probability of stability and reliability index of different length roof bolts, 3 roof bolts in a row
