# Table of Contents

The Virginia Department of Transportation, VDOT, has recently decided to replace a bridge on Rte. 668 over Gills Creek in Franklin County that is outdated and structurally deficient. The new bridge will consist of three simple spans, one of which will utilize Glass Fiber Reinforced Polymer, GFRP, reinforcing bars as the top mat of reinforcement and epoxy coated mild steel as the bottom mat of reinforcement. This bridge, in particular, was chosen for the project because of its rural location, just in case any unforeseen problems happen to arise with the use of the GFRP bars. The design for the span containing the GFRP bars was accomplished using the ACI 440 *Guide for the Design and Construction of Concrete Reinforced with FRP Bars* (2001) in conjunction

The primary objective of this project is to test a full-scale prototype of the actual bridge deck containing the GFRP bars. This is to verify that the design will resist the loads for which it was designed and to provide VDOT engineers with assurance that they have a good design that will not unexpectedly fail due to the use of this new material. Within this scope, it will be determined if the design is conserv

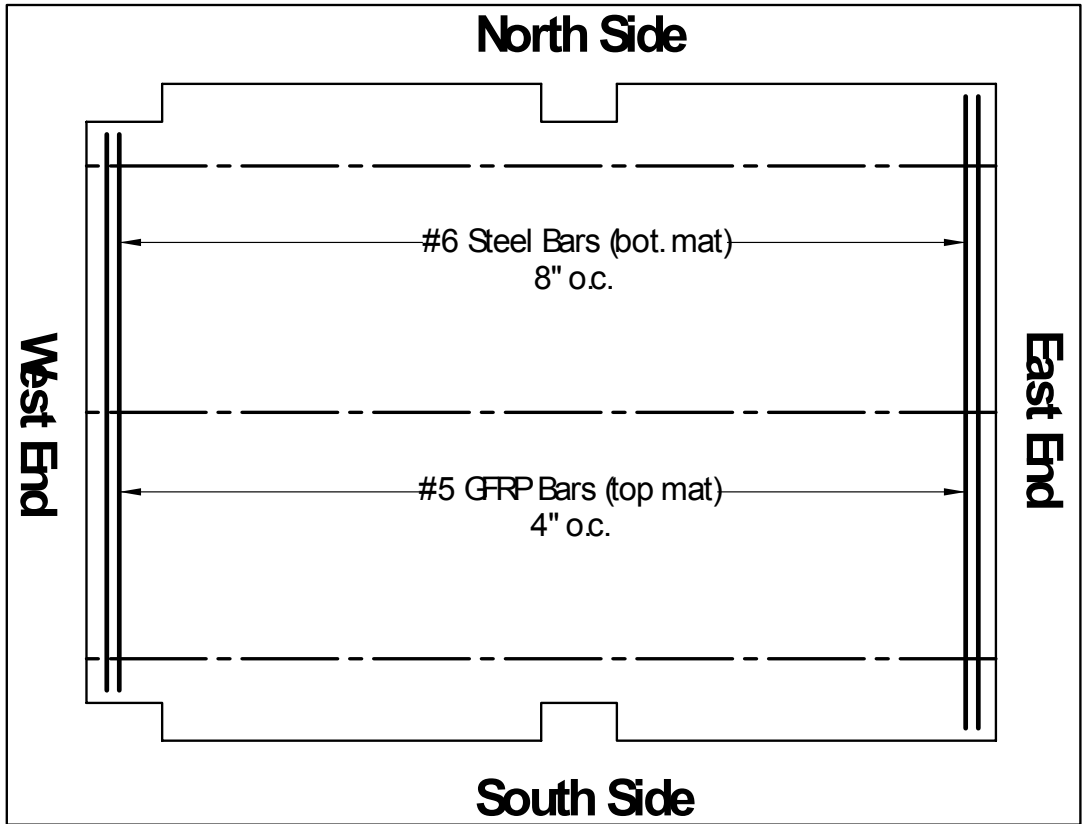
Figure 3. 4: Transverse Reinforcement Layout

The No. 6 mild steel bars were spaced 8 in. on center in the transverse direction (Figure 3.4). They had a cover depth of 1 in. between girders and 2 in. on the overhangs. The longitudinal No. 4 steel bars were laid on top of the transverse bars. From the centerline of the exterior girder to 2 in. from the edge of the overhang, there were five equal spaces and the bars are spaced approximately  $4 \frac{4}{5}$  in. on center with no bar placed over the girder. From the centerline of the exterior girder to a distance 1 ft.  $7 \frac{1}{2}$  in. towards the interior, there is one bar over the edge of the girder and two equal spaces of  $7 \frac{1}{4}$  in., and this is the same spacing for the interior girder towards the exterior with no bar over the girder. The 3 ft 3 in. in-between is divided into eight equal spaces corresponding to bars placed  $4 \frac{7}{8}$  in. on center (Figure 3.5). The spacing is the same on both sides of the interior girder.

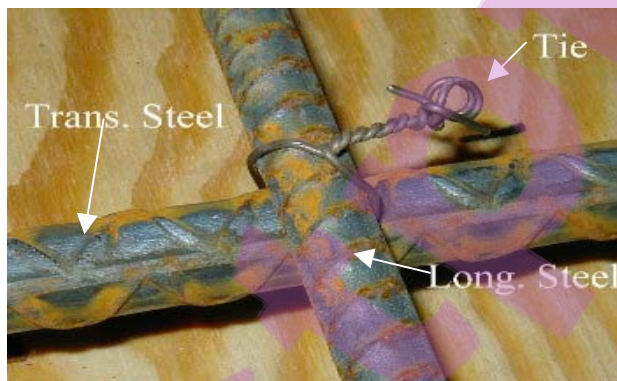
**Figure 3. 8: Bottom Steel Mat Tie**

One inch steel bar chairs were laid parallel to the girders between the girders, and two inch chairs were used on the overhang. The transverse steel was laid down and tied to the chairs. The longitudinal steel was then laid on top of and tied to the transverse steel (Figure 3.8).

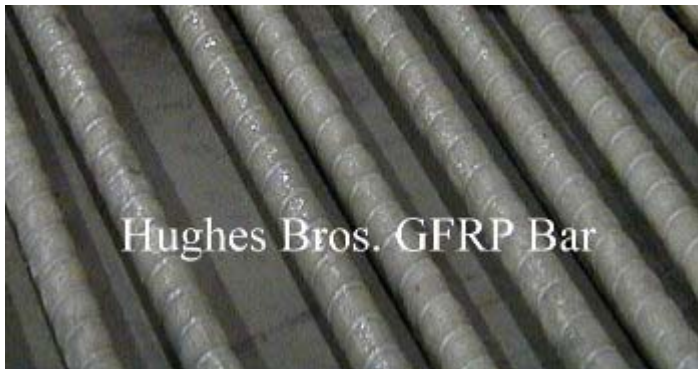
**Figure 3.11: GFRP Bar**

is vinyl ester. The bars were tested in the SATEC UTM using the same procedures and standards as used by DeFreese (2001). The clip on extensometer with a 2 in. gauge length was also used for this test to record the strains, and the computer recorded the stresses. Stress-strain curves were produced using the data. The stress-strain curves are linear-elastic up to failure, however, the extensometer was taken off before failure to prevent damage.

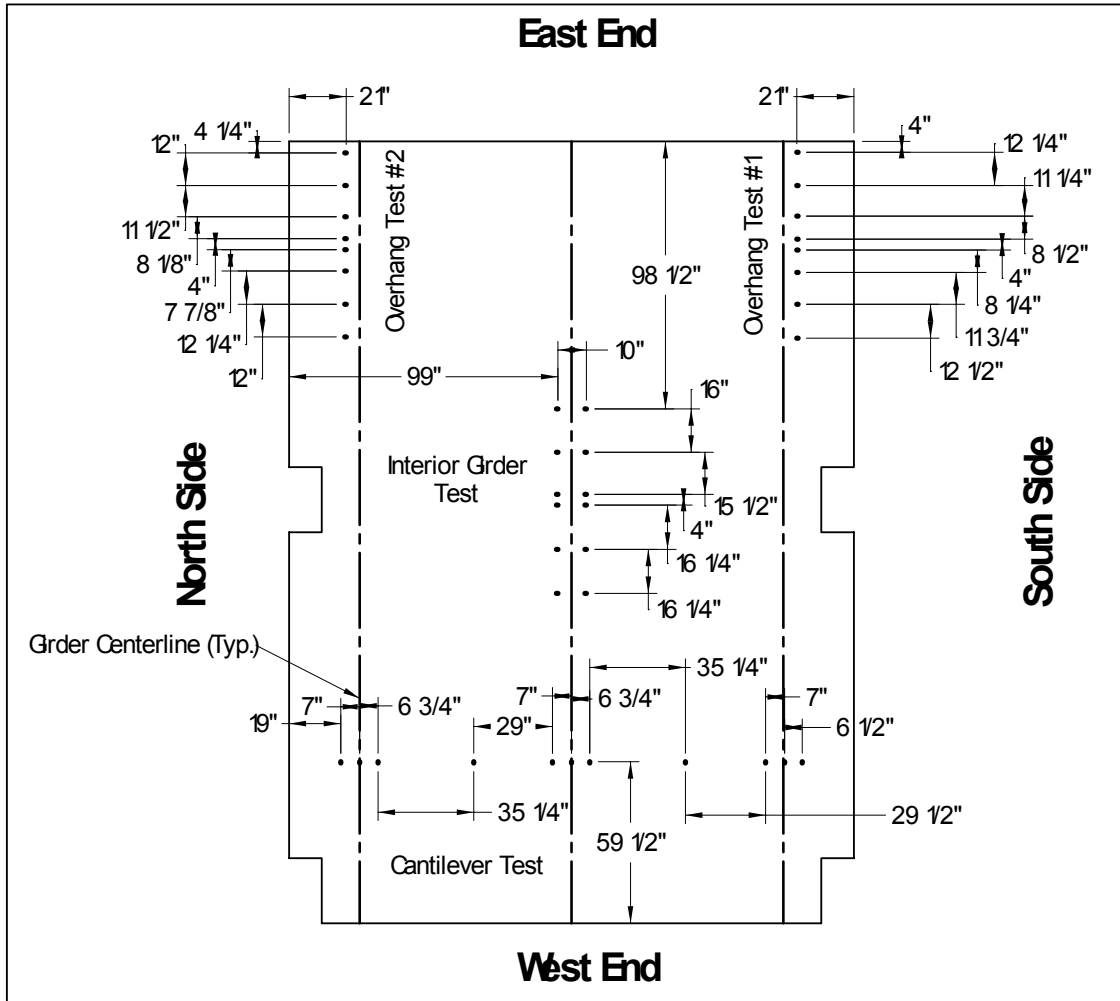
**Figure 3.14: GFRP Strain Gauge Locations**

Each of the two overhang tests had eight No. 5 transverse GFRP bars strain gauged and four No. 6 transverse steel bars strain gauged. Both the GFRP and steel strain gauges were positioned along the outer edge of the exterior girder's flange. This distance measured 21 in. from the North and South sides for tests #1 and #2, respectively. For Overhang test #1, North side, the gauges were positioned as shown in Figure 3.14, and all the gauges were  $2\frac{3}{8}$  in. from the top of the slab. For Overhang test #2, South side, the gauges were positioned as shown in Figure 3.14, and all the gauges were  $2\frac{1}{2}$  in. from the top of the slab. The steel gauges were positioned as shown in Figure 3.15 the slab, and were  $2\frac{1}{4}$  in. from the bottom of the slab for both tests. All of the strain gauges for all of the tests were oriented along the length of the particular bar that they were affixed to.

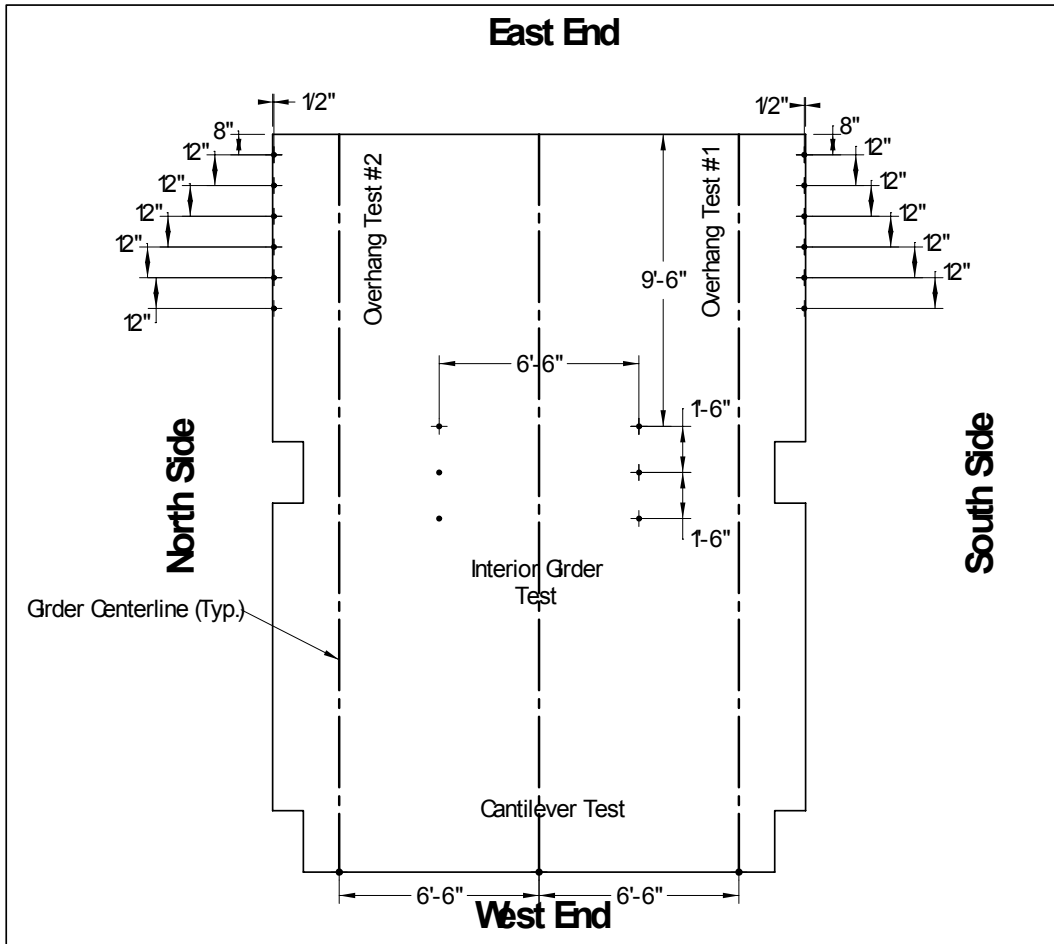
Figure 3.16 : Wire Pot Locations

The wire pots used to measure deflections were in the same locations for both tests. They were anchored to the bottom of the slab at  $\frac{1}{2}$  in. from the edge. The first pot was located 8 in. from the East end of the slab, and the other five were positioned 12 in. on center from the first (Figure 3.16).

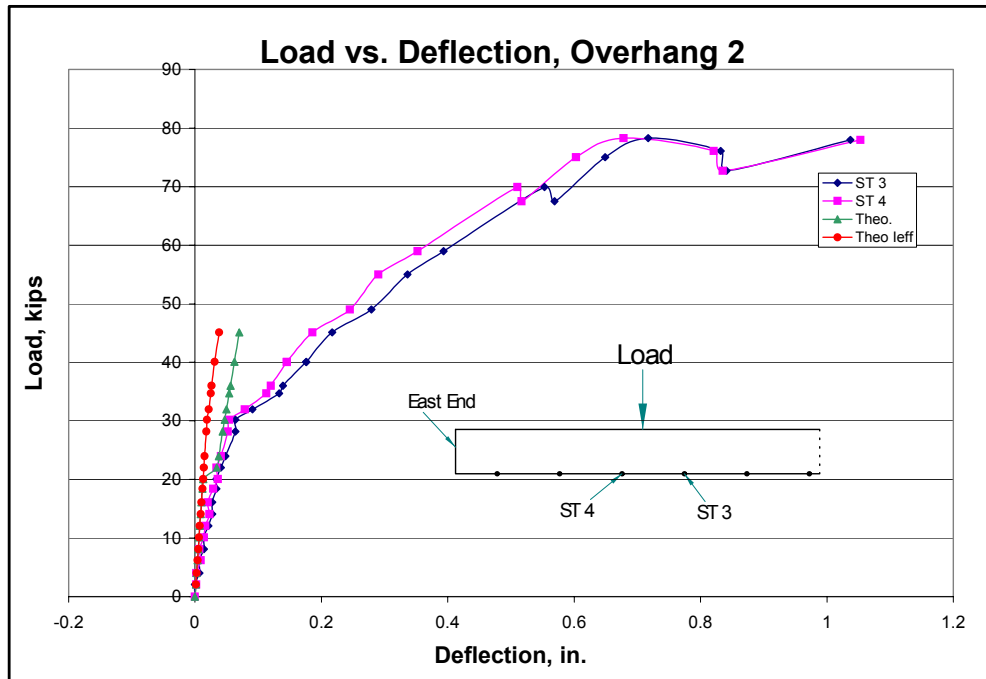
**Figure 4. 2: Load vs. Deflection Plot for Overhang #2**

Therefore, at 20 kips, the deflections in the overhang section were calculated using  $I_{cr}$  as opposed to  $I_t$ . For the ‘Theo.  $I_{eff}$ ’ data series,  $I_e$  was equal to  $I_t$  up to a load of 32 kips.

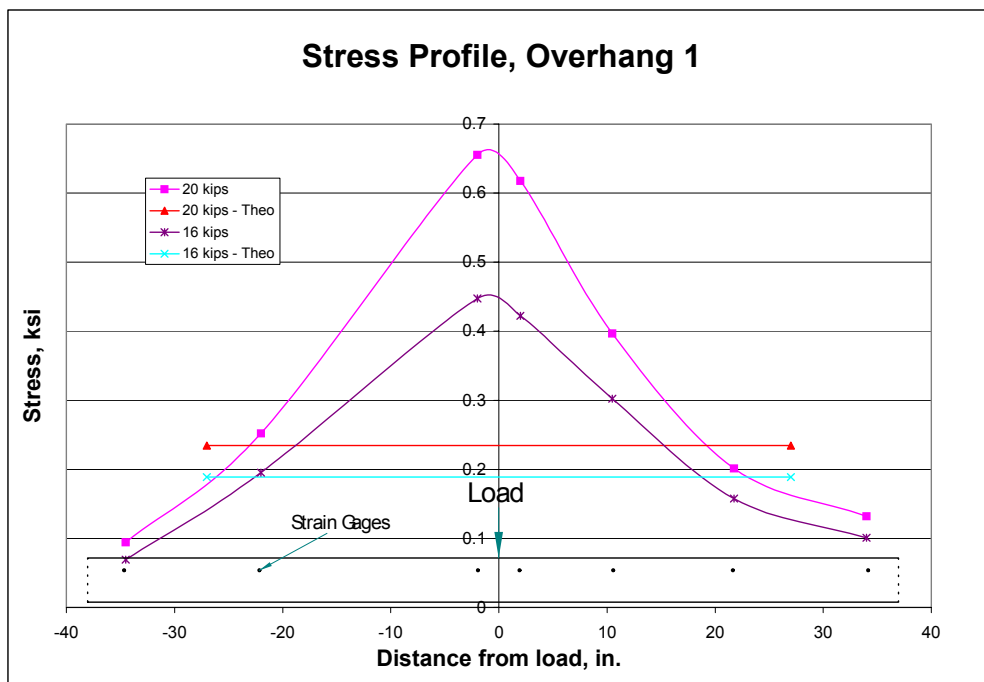
Figure 4.5: Stress Profile of Overhang #1, Pre-Cracking

The stresses in the GFRP bars were obtained by multiplying the recorded strains by the modulus of elasticity of the GFRP bars, 6300 ksi. Stress profile curves were then created at various loads. These plots showed the stress in each bar relative to its distance from the load point. Figure 4.5 is a stress profile plot for loads of 16 kips and 20 kips. As can be seen and as expected, the stresses are highest closer to the load and taper off as

Figure 4.5 also contains calculated theoretical values for the stresses in the bars. These were calculated by multiplying the effective load by a moment arm of 11 in. to obtain an effective moment. Since the section was not cracked at these two loads, the moment was multiplied by  $y$ , the distance from the bar to the neutral axis, 1.935 in., and then divided by the transformed moment of inertia,  $I_t$ . The theoretical stress is plotted over the 4 ½ ft effective width, and should match the peak stresses in the measured data, but it is significantly less. As can be seen, with the load increased from 16 kips to 20 kips, the predicted value becomes more unconservative. Therefore, it is doing a better job of predicting stresses at lower loads before cracking, but is still unconservative at the low loads.

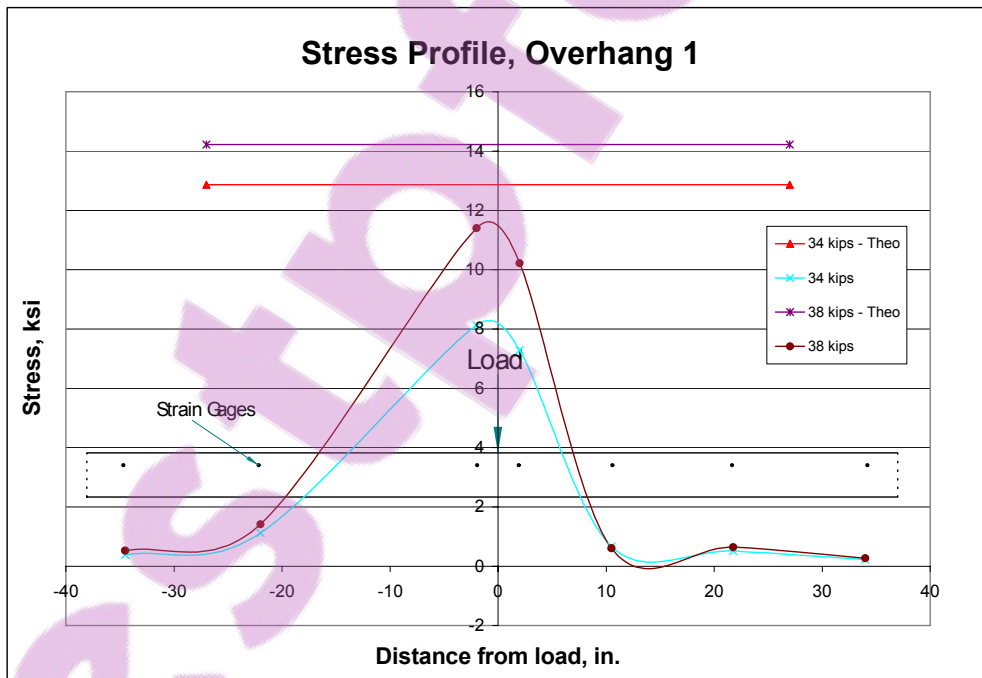
Figure 4.6: Stress Profile for Overhang #1, Post Cracking

Figure 4.6 is the same type of stress profile, only at higher loads of 34 kips and 38 kips. This is considered to be after the section had cracked based on observations and data. The same pattern of higher stresses closer to the loads is again seen in this plot. The theoretical stresses were calculated in the same manner as before, only this time, the cracked moment of inertia,  $I_{cr}$ , was used and the  $y$  value increased to 4.735 in. Now, the theoretical values are conservative and over-predicting the measured stresses. The theoretical stresses are however becoming less conservative with increased load. This is because the theoretical stresses are being calculated assuming that the section is completely cracked, when it is not. The section is only beginning to crack and as the load increases, the section will become more and more cracked and the measured values will begin to approach the theoretical values.

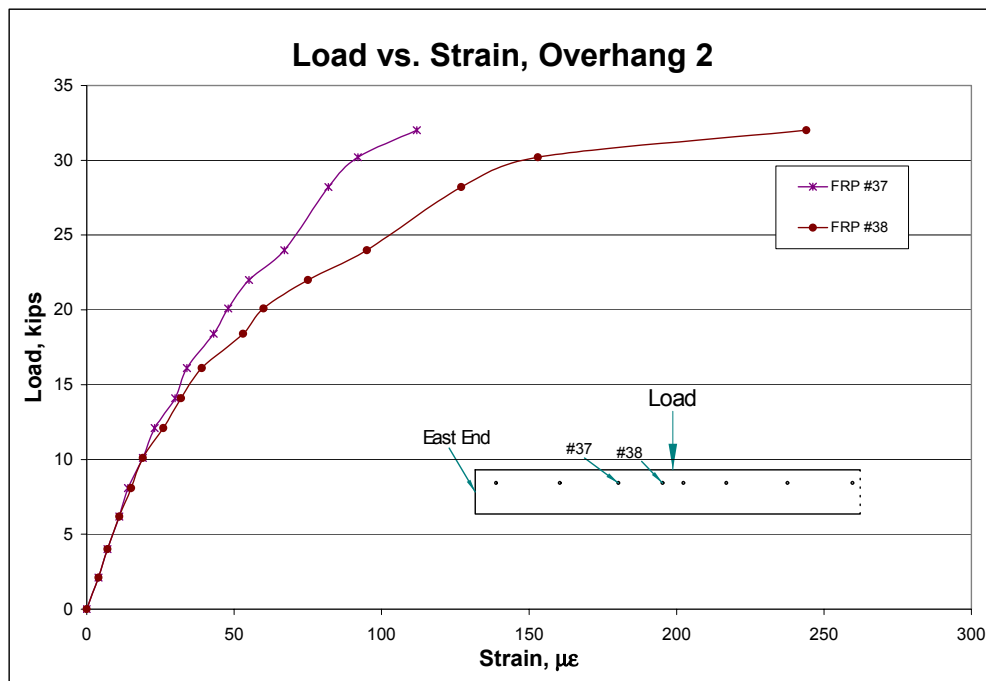
**Figure 4.8: Load vs. Strain Plot for Overhang #2, GFRP bars**

cracking of the section and then visible cracking around 22 kips. The slope changes again around 32 kips, this time it is a very drastic change, as the section has become more cracked.

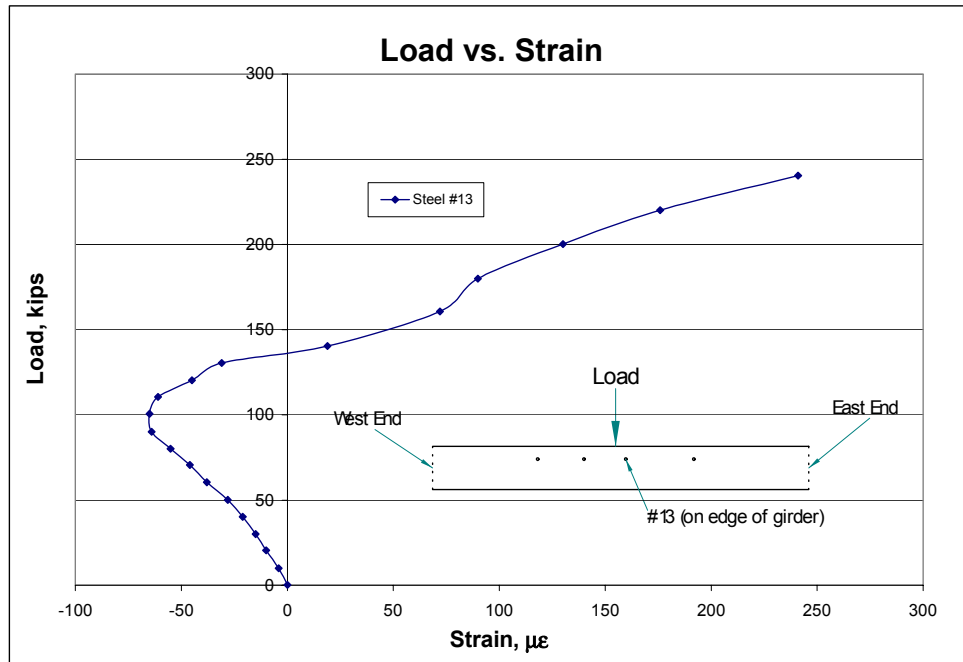
**Figure 4.14: Load vs. Strain Plot for Interior Girder Test, Steel Bars**

Figure 4.14 is a load vs. strain plot of steel strain gauge #13. The location of the gauge is shown in the plot. The slope of the plot is negative up to a load of 90 kips, indicating that the bar is initially below the neutral axis and is in compression. At this point the slope goes to infinity, then becomes positive at 110 kips. This indicates a crack in the section and the gradual lowering of the neutral axis. At 140 kips, the bar is in tension because the section has become so cracked that the neutral axis has now dropped below the bar.

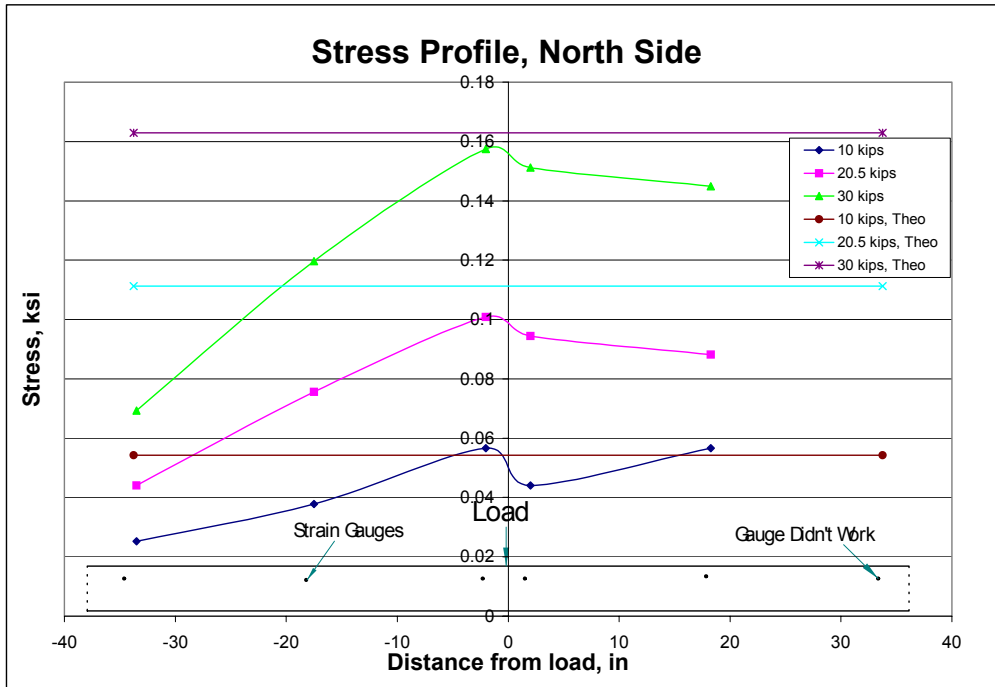
**Figure 4.16: Stress Profile of Interior Girder Test, Pre-Cracking**

The stresses in the GFRP bars were obtained by multiplying the recorded strains by the modulus of elasticity of the GFRP bars, 6300 ksi. Stress profile curves were then created at various loads. These plots showed the stress in the bars relative to its distance from the load point. Figure 4.16 is a stress profile plot for loads of 10, 20, and 30 kips. As can be seen and as expected, the stresses are highest closer to the load and taper off as gauges get further away from the load.

Figure 4.16 also contains calculated theoretical values for the stresses in the bars. These were calculated by using the effective moment at the edge of the girder flange found in the previously mentioned RISA-2D (1993) analysis. Since the section was not cracked at these three loads, the moment was multiplied by  $y$ , the distance from the bar to the neutral axis, 1.65 in., and then divided by the transformed moment of inertia,  $I_t$ . The theoretical stress is plotted over the 5 ft 7 ½ in. effective width, and should match the peak stresses in the measured data, which it is doing pretty well. As can be seen, with the load increased from 20 kips to 30 kips, the predicted value is still over-predicting, but becoming more unconservative. Therefore, it is doing a better job of predicting stresses at lower loads before cracking, but is still slightly unconservative at the low loads closer to cracking.

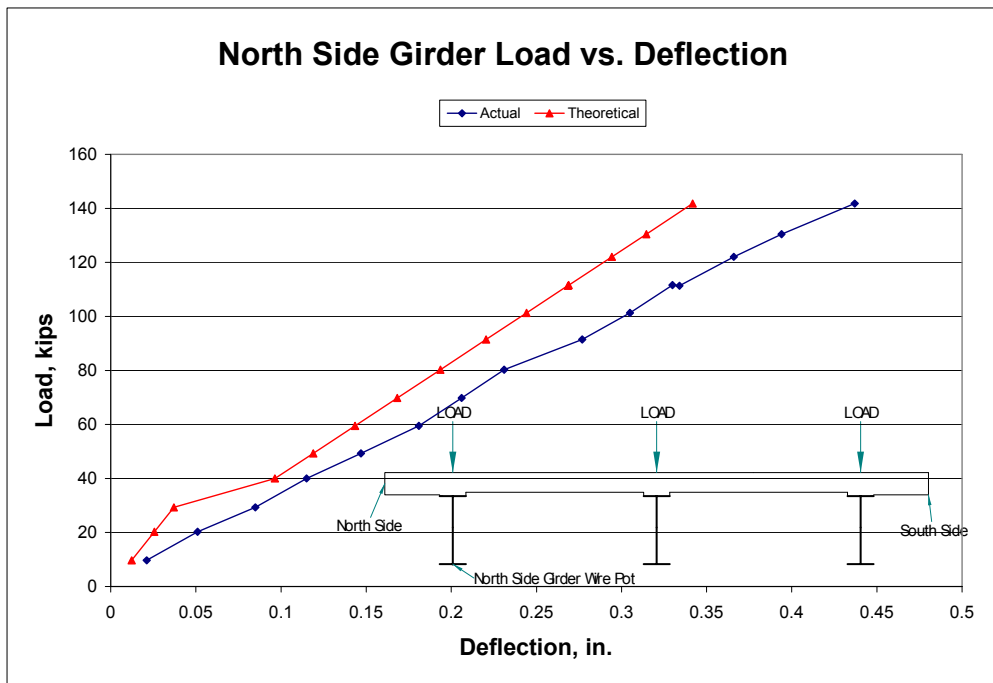
The wire pots were attached to the bottoms of the girders with magnets. They were attached to the ends of the girders on the West end. The data was collected during the testing and load vs. deflection plots were created. Figures 4.19 and 4.20 below are two of the plots that were created.

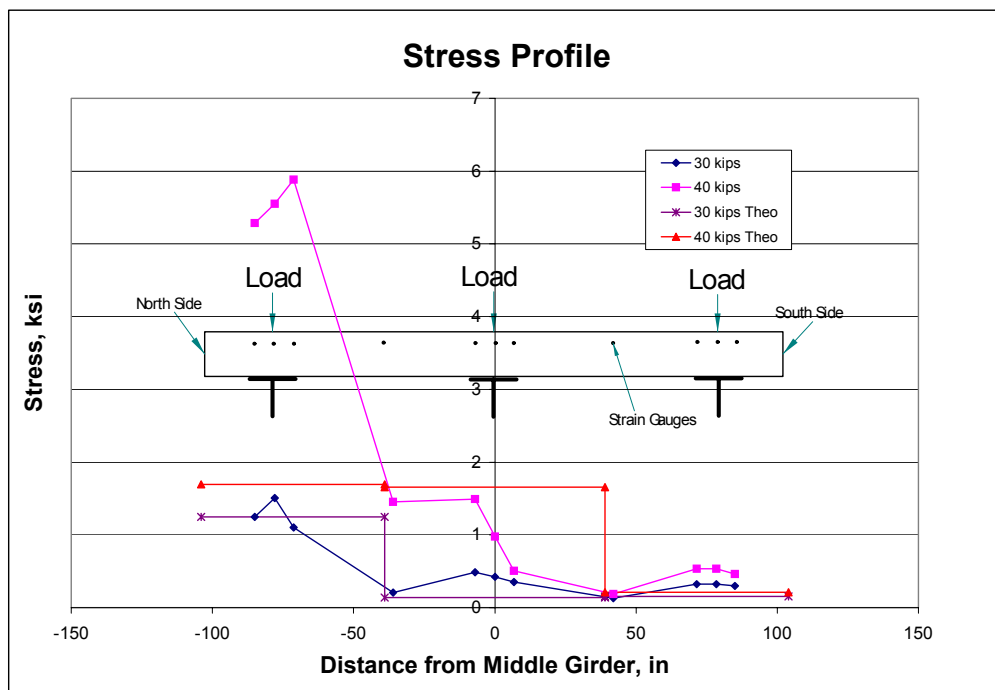
Figure 4.24: Stress Profile for Cantilever Test

The stresses in the GFRP bars were obtained by multiplying the recorded strains by the modulus of elasticity of the GFRP bars, 6300 ksi. Stress profile curves were then created at various loads. These plots showed the stress in the bars relative to its distance from the load points. Figure 4.24 is a stress profile plot for loads of 30 and 40 kips. As can be seen and as expected, the stresses are highest closer to the load and taper off as gauges get further away from the load.
